## Inspection Report

Provided by: Home Tactics Inspection Services LLC

Sample Report --- Address Confidential ---Sample Report

## 1 Report Information

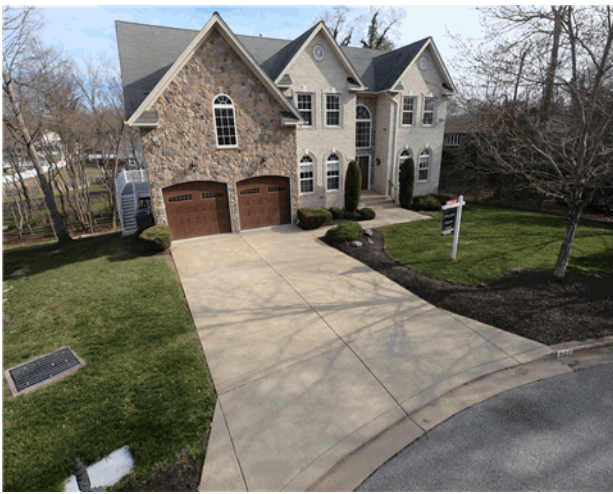
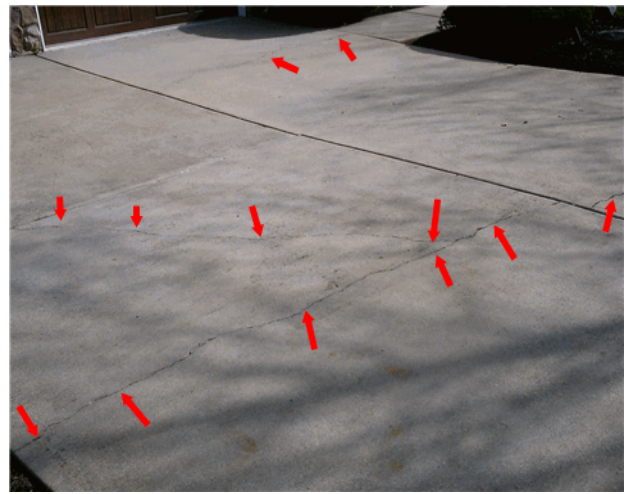
**2) Driveway Conditions** AS The driveway appeared to be in serviceable condition at the time of the inspection. Common cracks were observed in the driveway. Recommend sealing cracks if they get any wider.

Recommend sealing cracks in driveway if they get any wider.

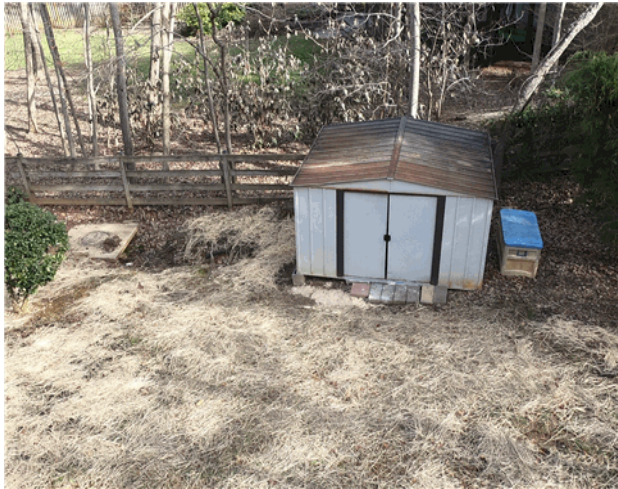
The left shed door was off track at time of inspection. Recommend repair / adjustment.

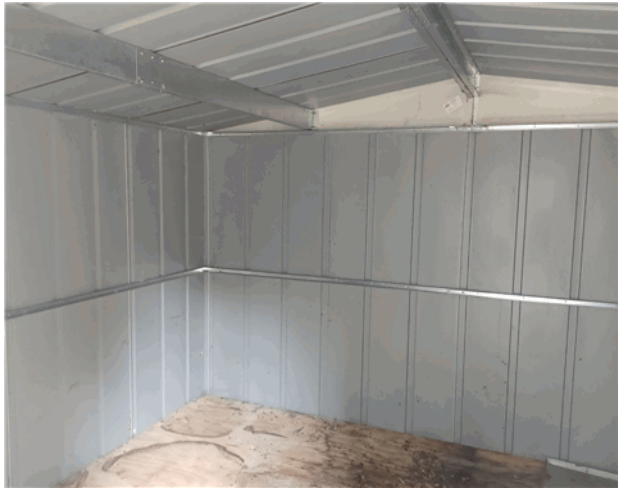
The left shed door was off track at time of inspection. Recommend repair / adjustment.

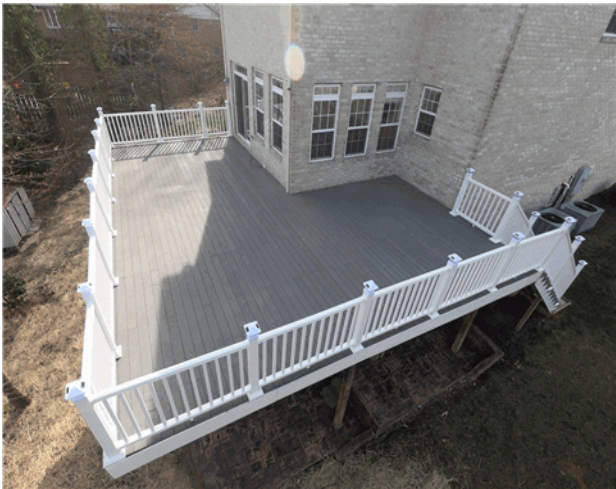
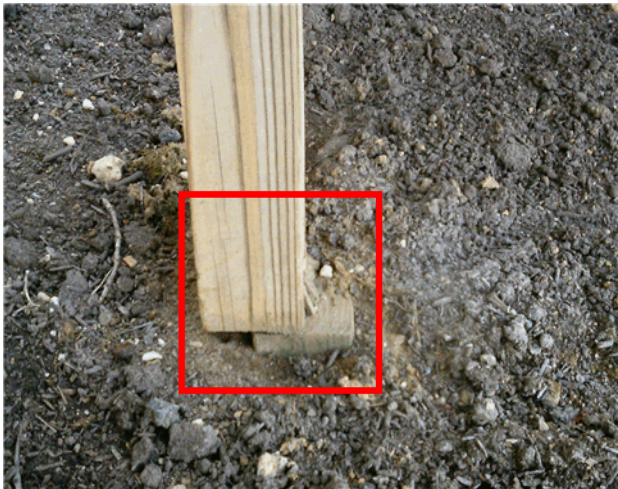
The right support post for the deck stairs appeared to have been cut. The deck stairs were unstable at time of inspection. Recommend repairing deck stair support for added safety. The rest of the visible and accessible areas of the deck appeared to be in serviceable condition at the time of the inspection.

The right support post for the deck stairs appeared to have been cut.  
(Safety issue)

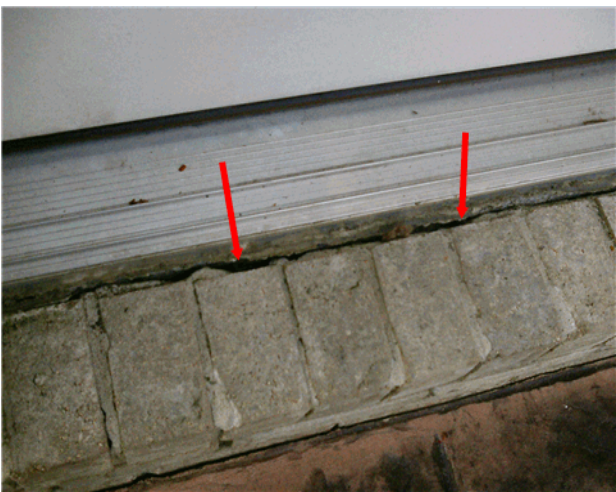
There was a gap at the bottom of the basement entrance doors that could allow moisture to enter behind the brick. Recommend sealing gap below basement entrance doors.

Gap at bottom of the basement entrance doors that could allow moisture to enter behind the brick.

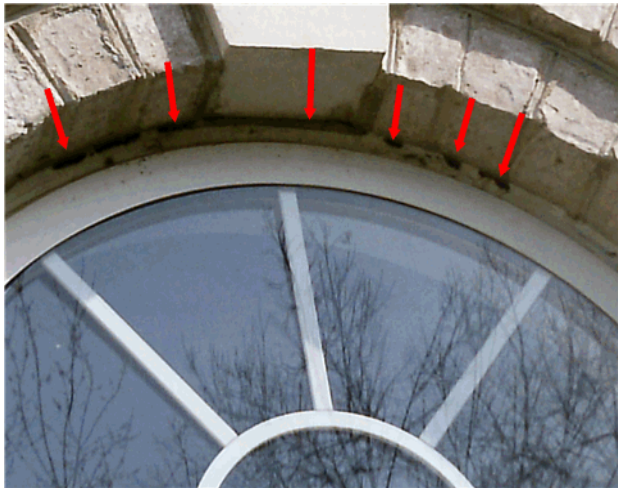
Some of the windows are in need of re-caulking around the exterior of them. It is important to caulk any cracks / seems in window framing to avoid moisture issues. Due to the state of the current caulking, moisture penetration may have already occurred.

Some of the windows are in need of re-caulking around the exterior of them.

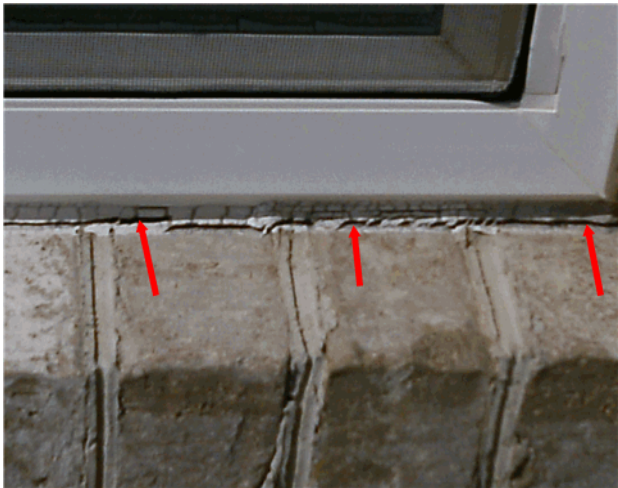
Some of the windows are in need of re-caulking around the exterior of them.

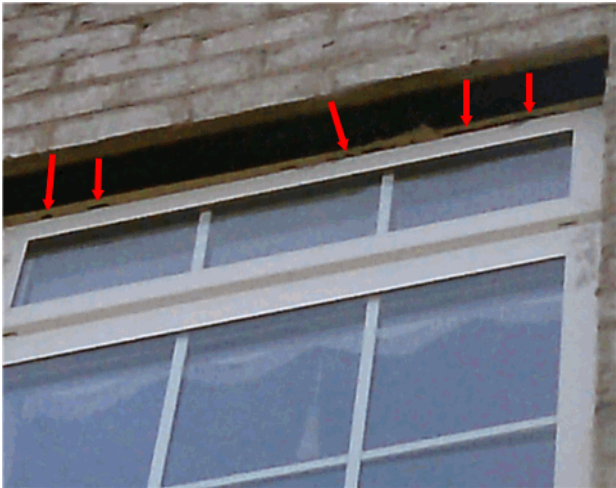
Some of the windows are in need of re-caulking around the exterior of them.

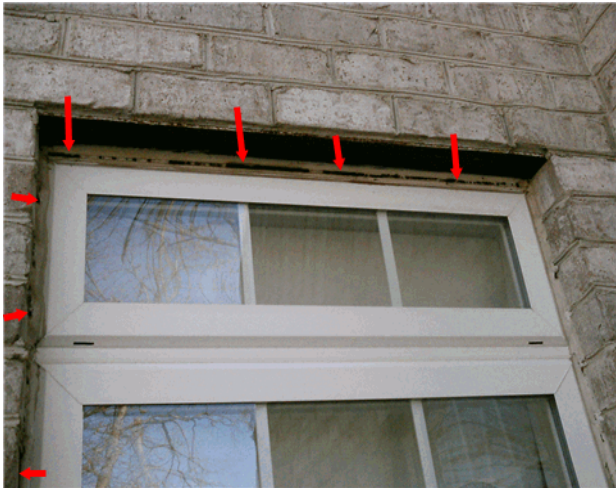
It is important to caulk any cracks / seems in window framing to avoid moisture issues.

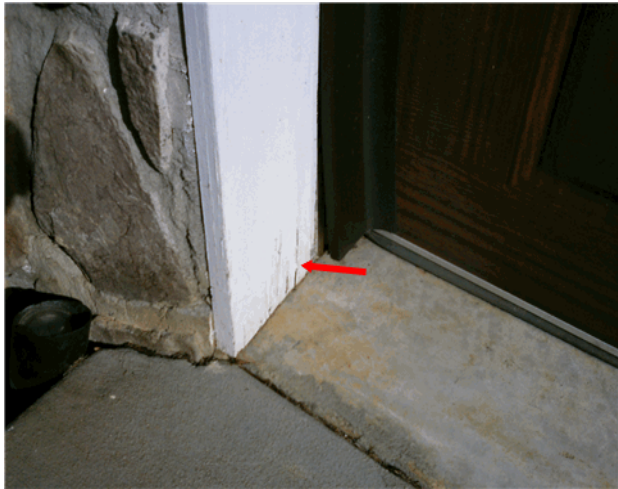
Recommend painting wood door frames that are weathered to help prolong the life of the wood.

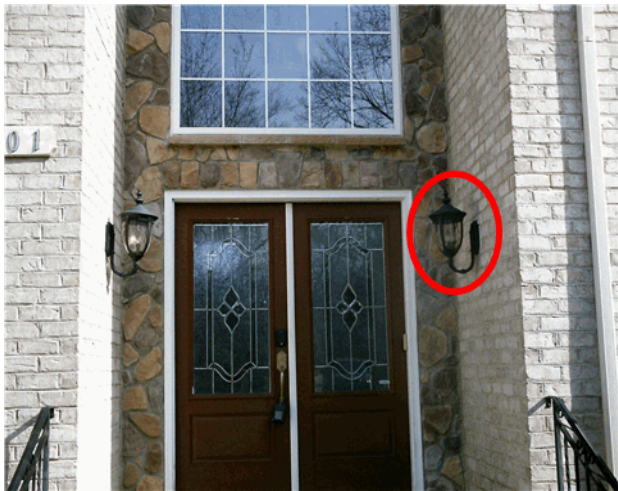
The exterior lighting to the right of the front entrance did not operate at time of inspection. It is beyond the scope of a home inspection to disassemble light fixtures to determine if the issue is the light fixture itself or just a burned out light bulb. Recommend replacing the bulb and testing it before closing.

The exterior lighting to the right of the front entrance did not operate at time of inspection.

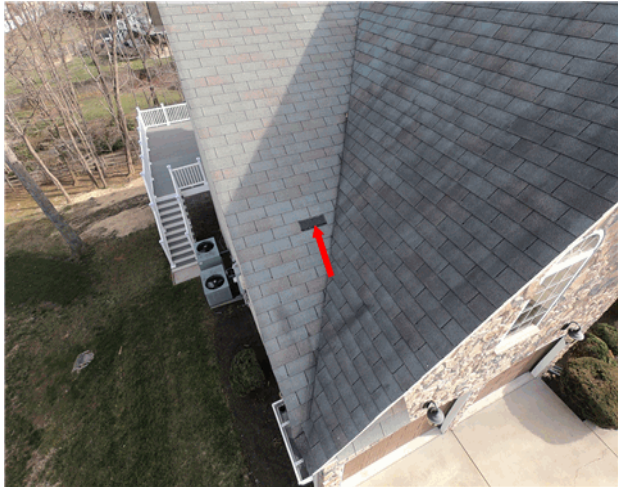
There was one missing shingle at the front of the home, and several missing shingles at the back of the home (left side of home). Recommend further evaluation and repair as needed by a qualified / licensed contractor. The inspector can not offer an opinion as to whether the roof leaks today unless it is moderately raining at the time of inspection. Client should obtain full disclosure / history information from the seller prior to close.

There was one missing shingle at the front of the home.

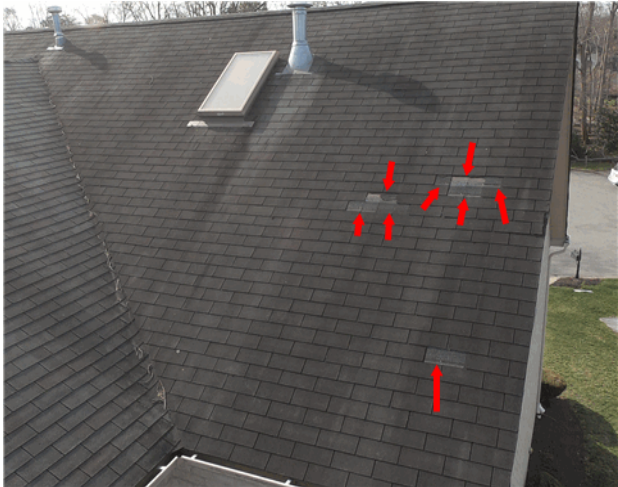
There were several missing shingles at the back of the home (left side of home).

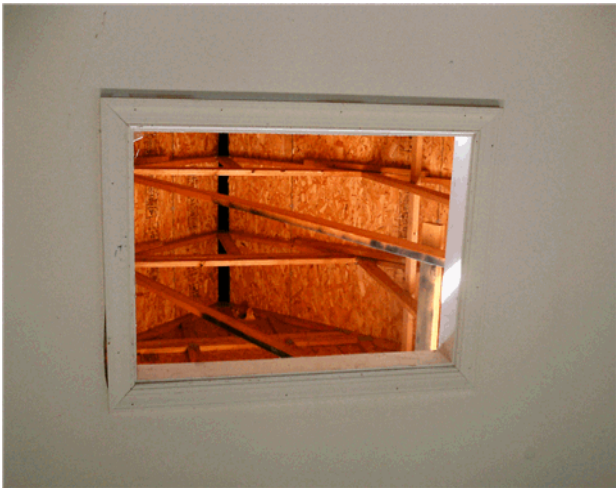
The attic access in the garage was missing the panel / board at time of inspection.

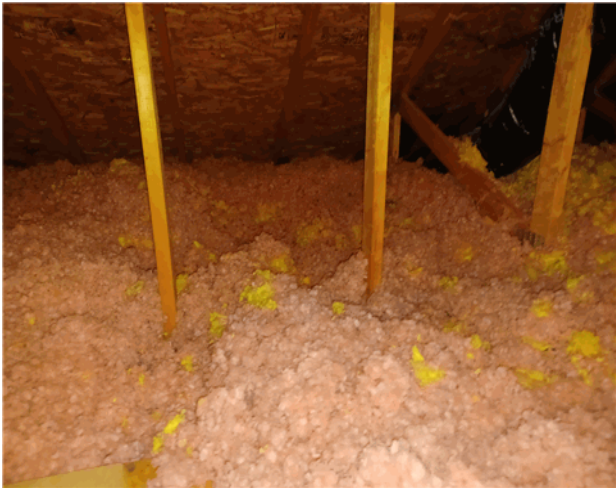
Recommend insulating top of attic access panel to help with energy costs.

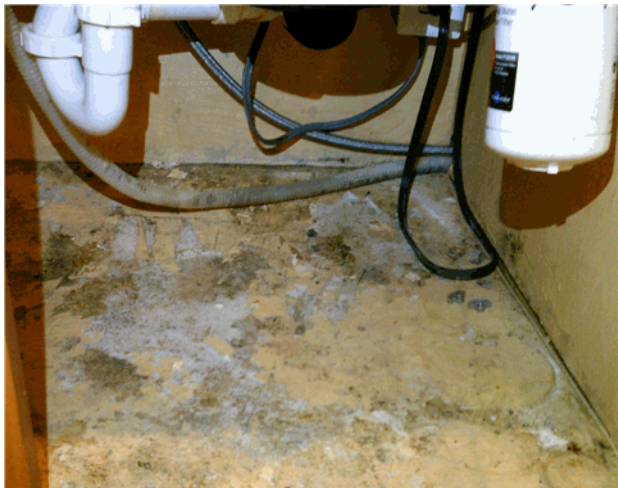
The cabinet under the kitchen sinks had water damage at the bottom.

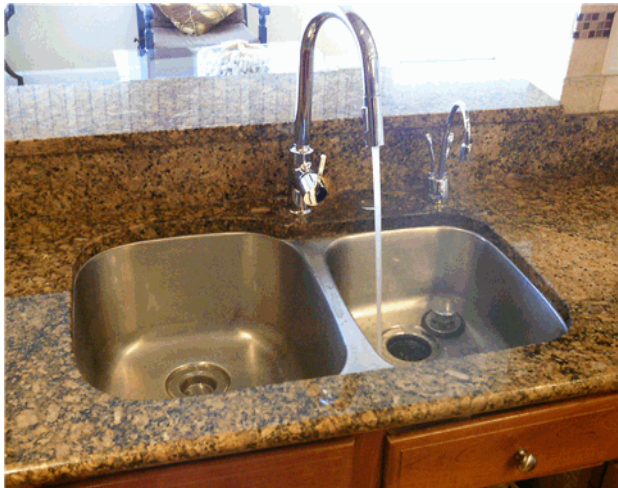
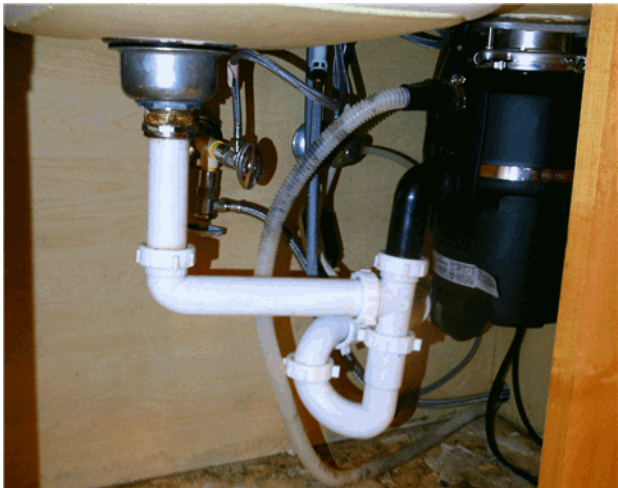
The drainpipes under the left sink were actively leaking at time of inspection. It is suggested that a "Licensed Plumbing Contractor" be contacted for further evaluation and repair.

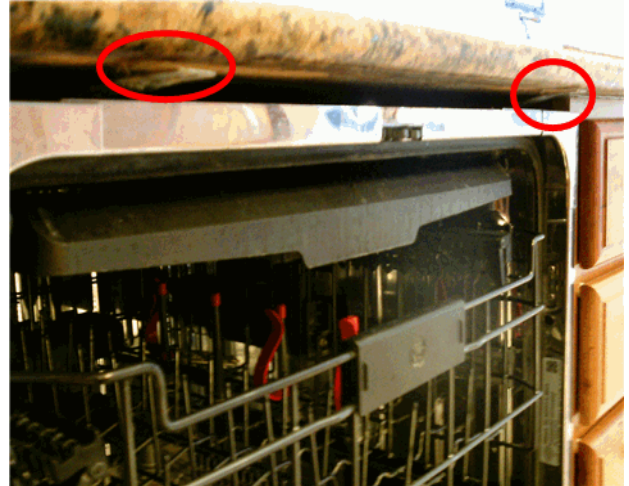
Dishwasher was not secured to cabinets / countertop.

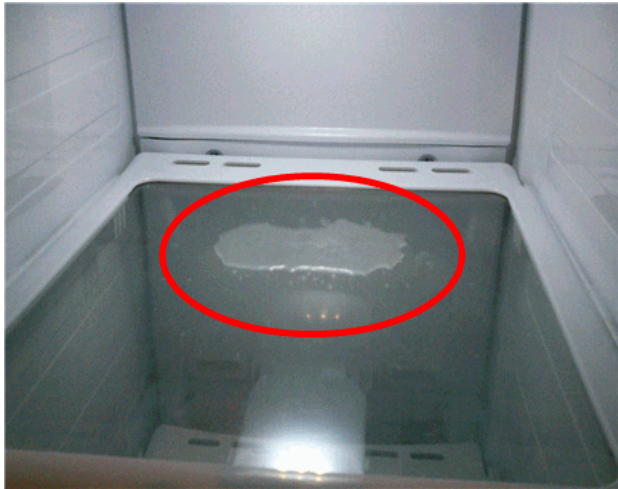
The refrigerator's ice maker appeared to be leaking.

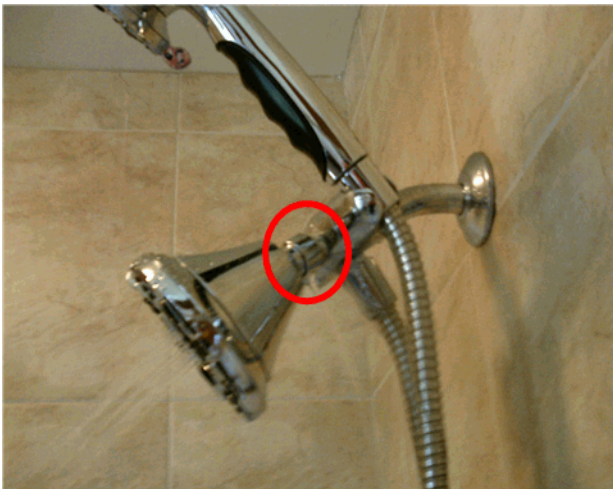
Water squirted out at the threads of the shower head in the master bathroom shower.

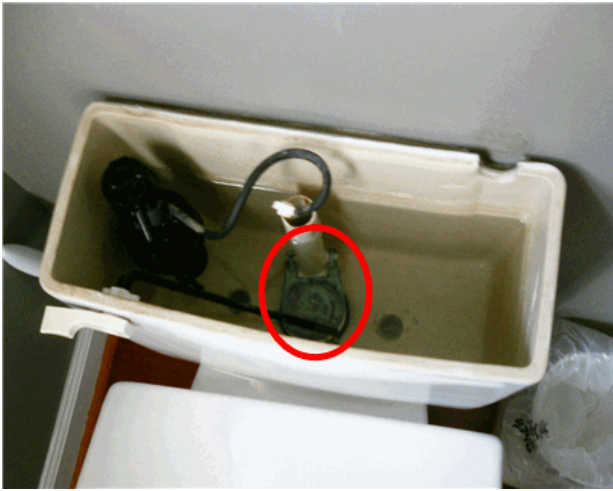
The toilet in the half-bath on the main level had a sticky flapper.

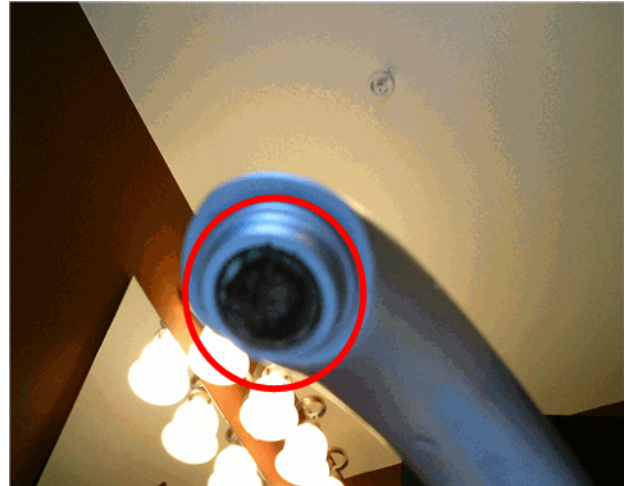
The aerator for the whirlpool appeared to be clogged, blocking proper water flow.

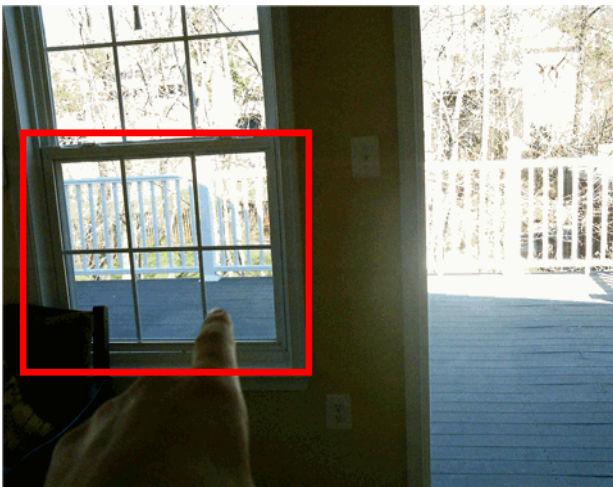
The window to the left of the back entrance door would not remain in the open position.

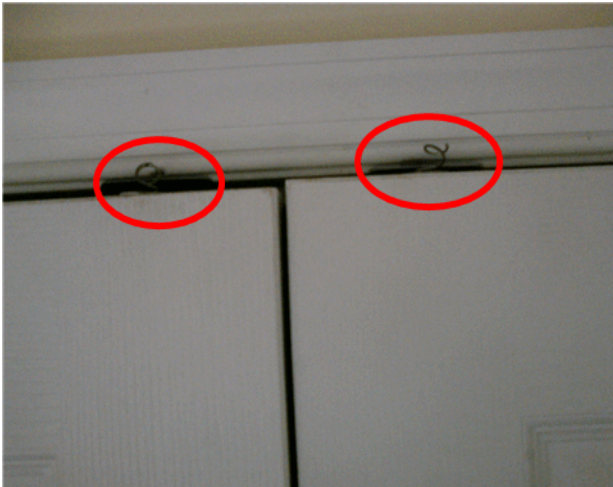
The locks at the top of the closet doors in the front right upstairs bedroom were damaged.

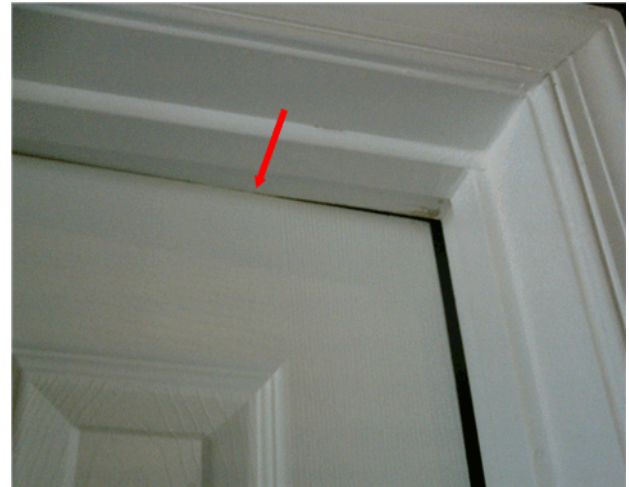
The left closet door in the master bedroom sticks at the door-frame.

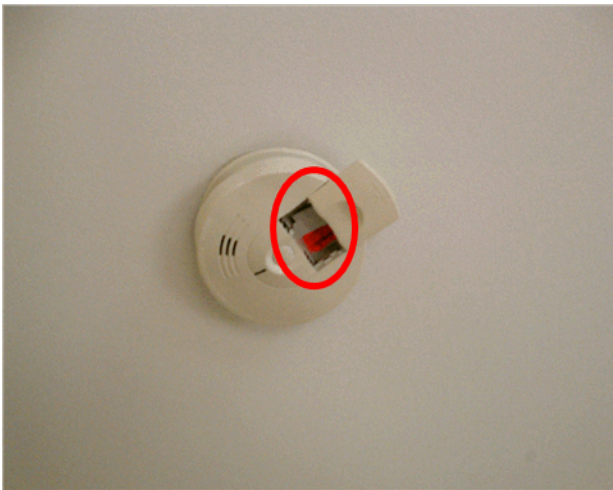
The smoke detectors in the front right upstairs bedroom and basement bedroom was chirping and the smoke detector in the front middle upstairs bedroom was missing the battery at time of inspection. The units may need a battery or replacement. Smoke detectors have a useful lifespan of about 10 years, it is recommended to replace all units after this time period.

Smoke detector in the front middle upstairs bedroom was missing battery. 2 others chirped.

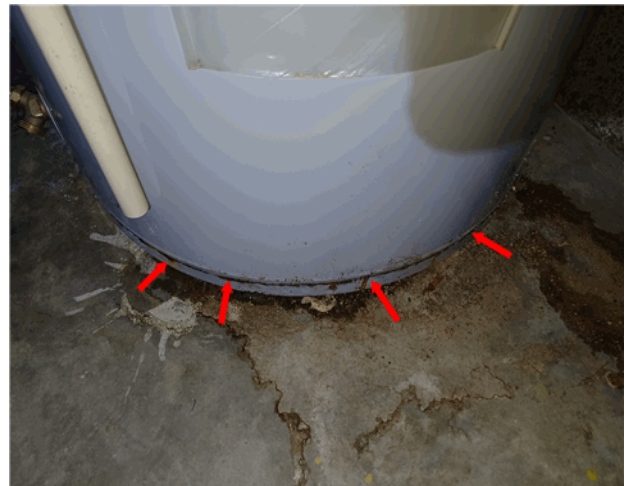
The water heater was operable at the time of inspection, but due to the age and / or conditions observed (rust at the bottom), the water heater is past the end of its useful life. Replacement is recommended in the near future before it completely fails and floods the basement.

Rust and water stains at the bottom are sure signs that the water heater is about to completely fail

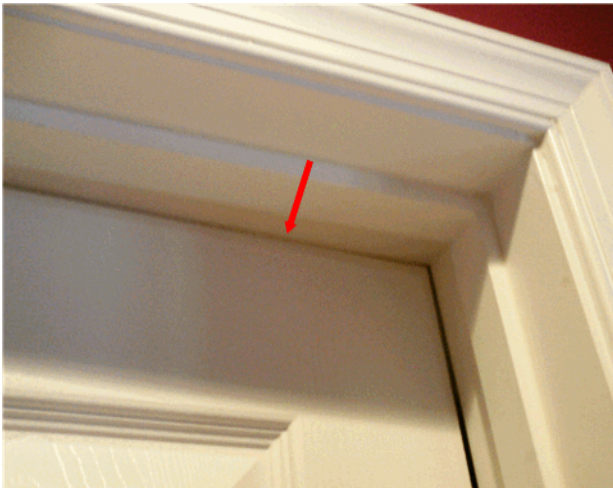
The door to the utility room in the basement sticks at the door-frame. Repairs and / or adjustments are recommended.

The door to the utility room in the basement sticks at the door-frame.
