## Inspection Report

Provided by: Home Tactics Inspection Services LLC

Sample Report --- Address Confidential ---Sample Report

## 1 Report Information

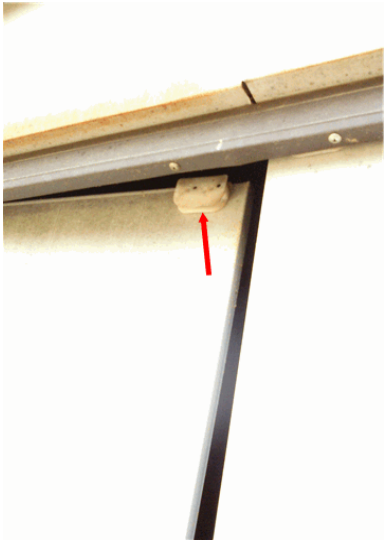
The left shed door was off track at time of inspection. Recommend repair / adjustment.

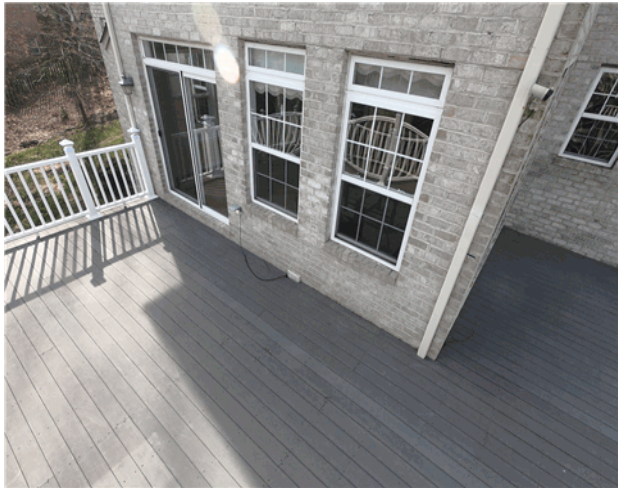
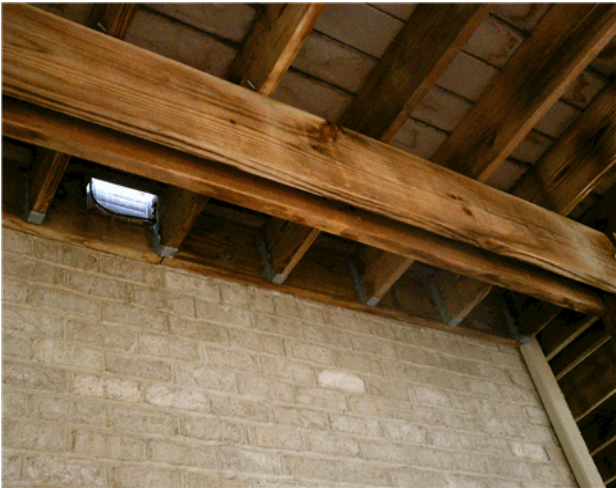
The right support post for the deck stairs appeared to have been cut.  
(Safety issue)

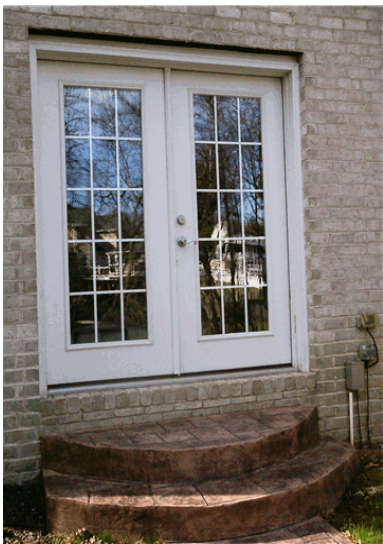
There was a gap at the bottom of the basement entrance doors that could allow moisture to enter behind the brick. Recommend sealing gap below basement entrance doors.

Gap at bottom of the basement entrance doors that could allow moisture to enter behind the brick.

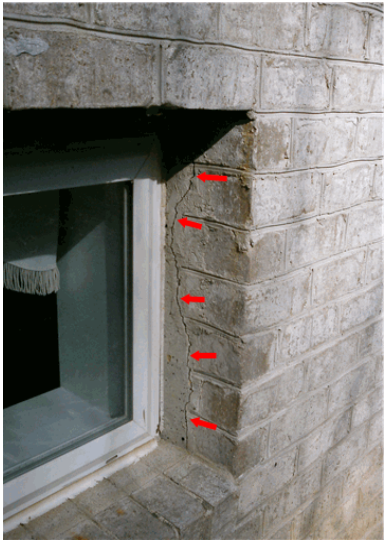
A minor crack in the brick was observed by the front basement window on the right side of the home.

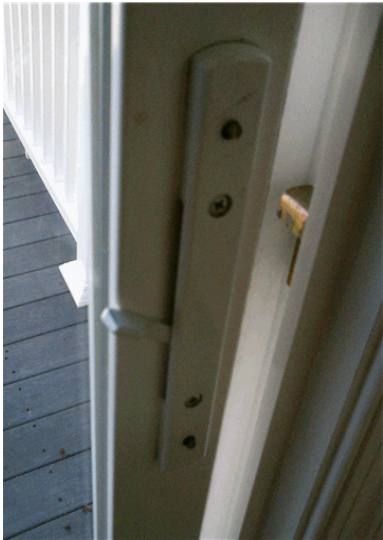
The back entrance door would not properly lock at time of inspection.  
(Security issue)

The back entrance door would not properly lock at time of inspection. This is a security issue. Recommend adjusting / replacing lock ASAP. The back entrance door was missing a handle on the inside. Recommend installing a handle to allow the back entrance door to be able to be opened from the inside. The exterior door frames were weathered. Paint and/or maintenance is recommended.

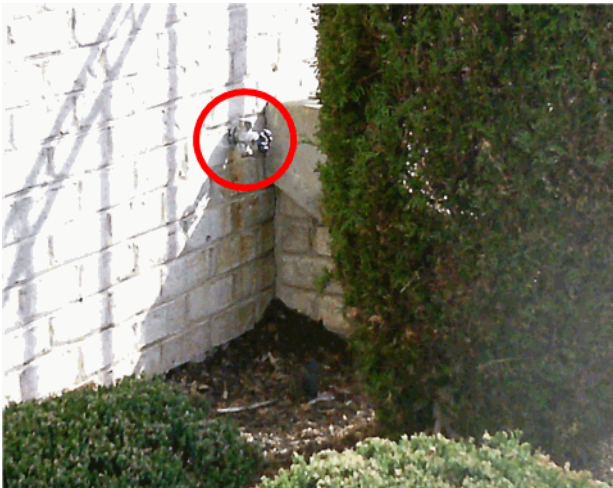
Exterior hose faucet could not be tested because it was valved off from the inside of the home.

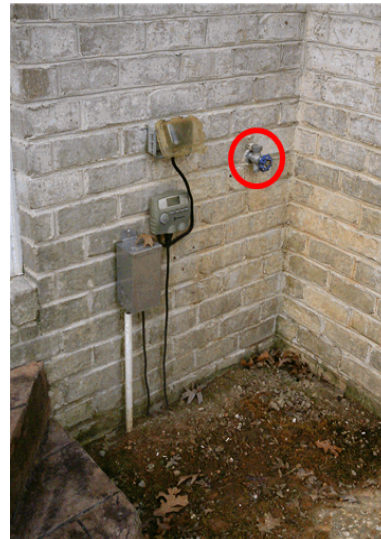
Exterior hose faucet could not be tested because it was valved off from the inside of the home.

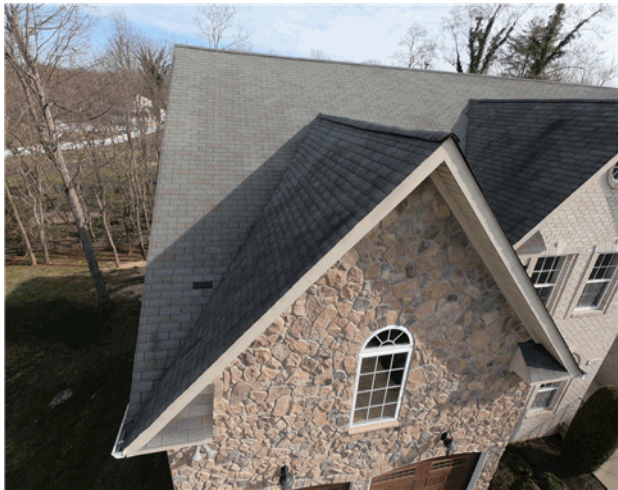
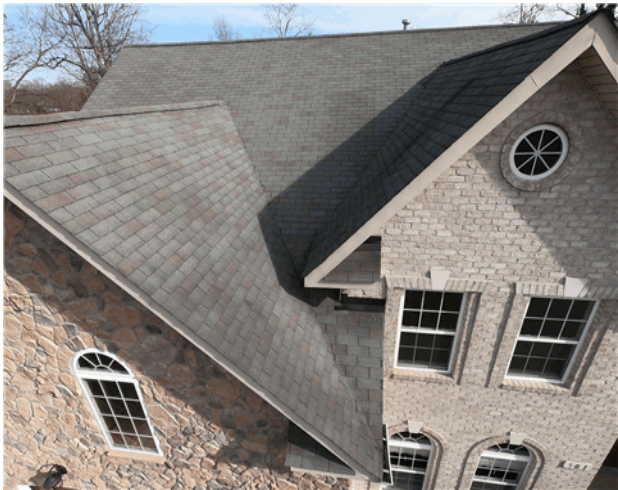
There were several missing shingles at the back of the home (left side of home).

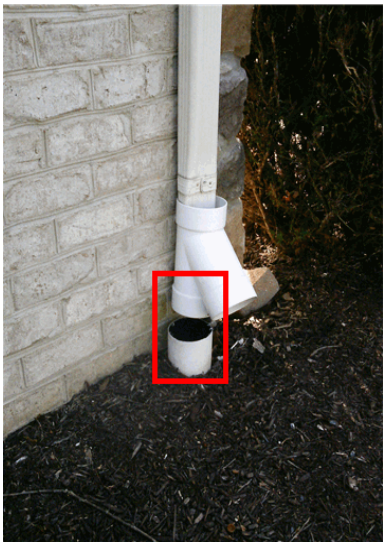
The down spout at the front left corner did not extend into the sub-surface drainage system.

The downspouts at the front left corner and by the front entrance did not extend into the sub-surface drainage system. Recommend extending those downspouts into the sub-surface drainage system to help avoid costly future foundation issues. Sub-surface drains were observed. These drains were not tested as a part of this inspection. Condition of underground pipes or location of their termination points (if any) is not determined as part of this inspection.

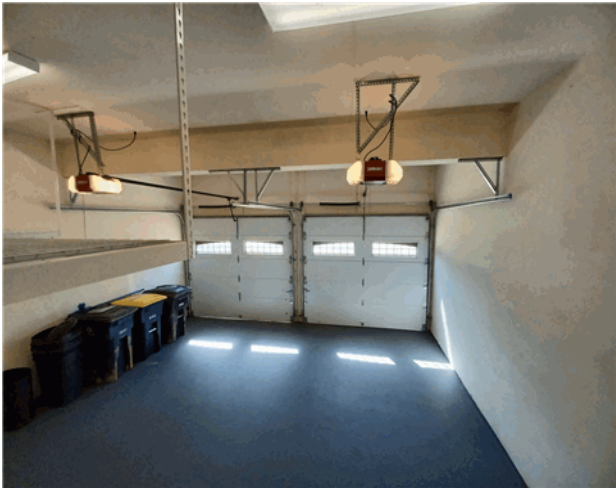
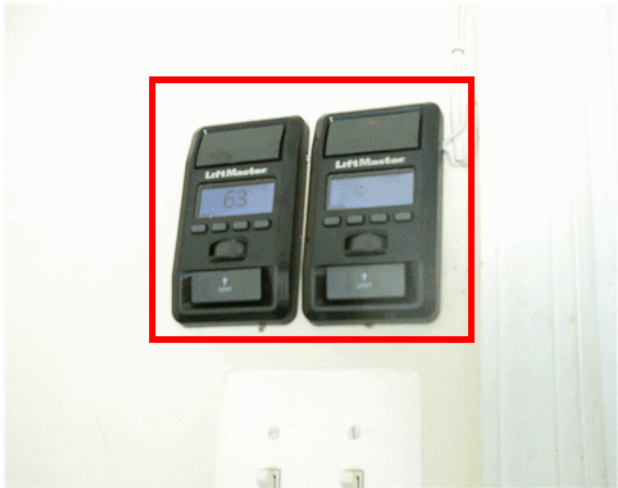
The vehicle door(s) appeared to be in serviceable condition at the time of the inspection, and both (electric eye and pressure-sensing) auto-reverse safety features performed properly when tested.

Vehicle door controls / openers.

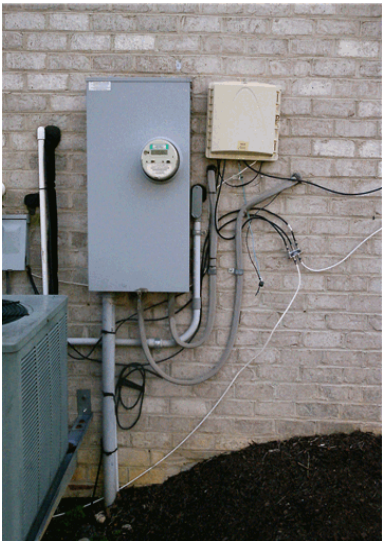
Main Electrical Panel

The main service entry appeared to be in serviceable condition at the time of inspection.

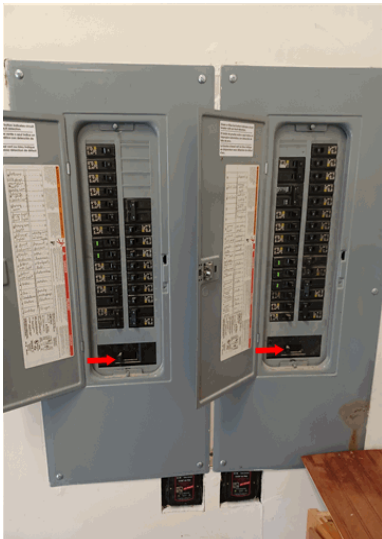
Main electrical shut-offs. (Shuts off power to entire home when both are off)

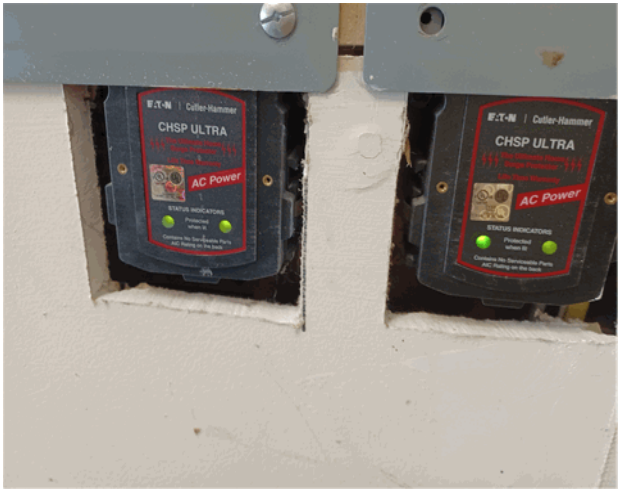
Home equipped with whole-home surge protectors.

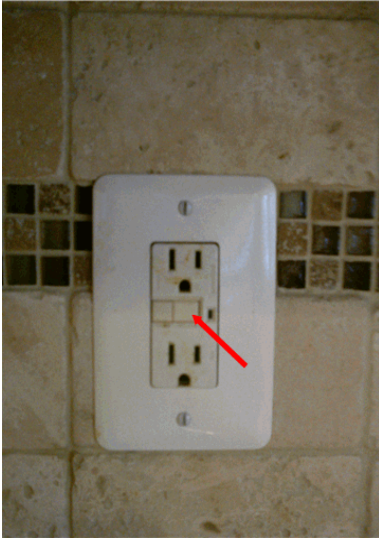
Electrical outlets in kitchen were GFIC protected for increased safety. (Push here to reset)

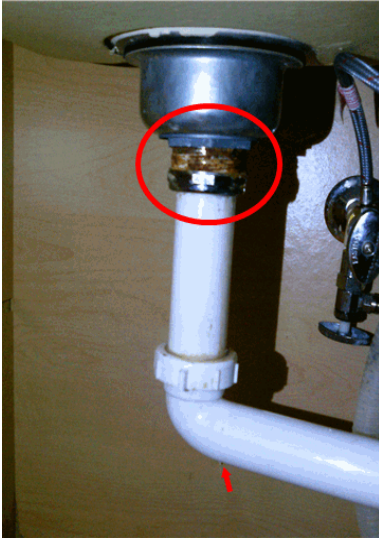
The drainpipes under the left sink were actively leaking at time of inspection. It is suggested that a "Licensed Plumbing Contractor" be contacted for further evaluation and repair.

The drainpipes under the left sink were actively leaking at time of inspection.

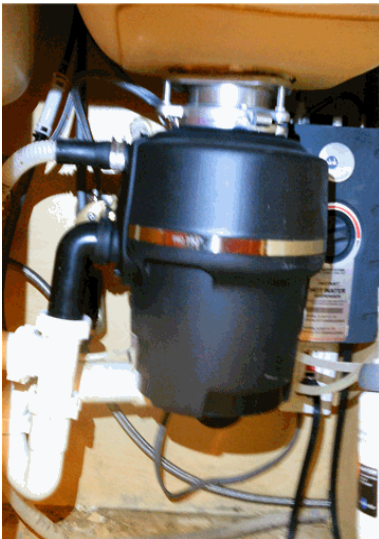
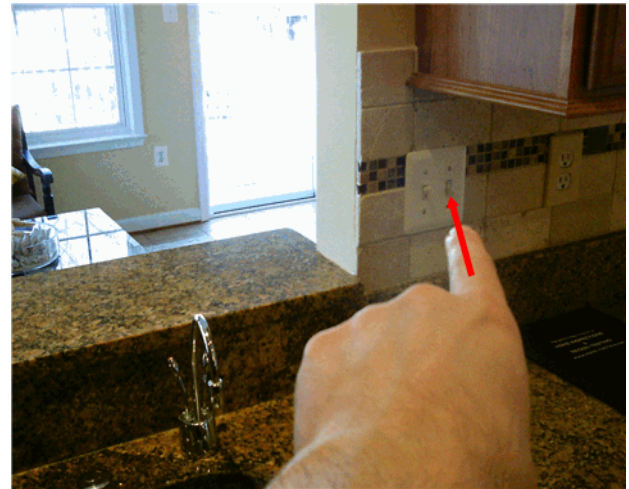
This switch operates the garbage disposal.

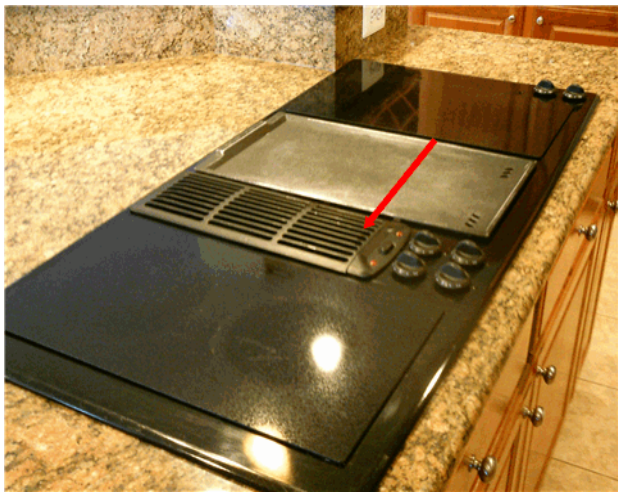
Exhaust fan built into cooktop.

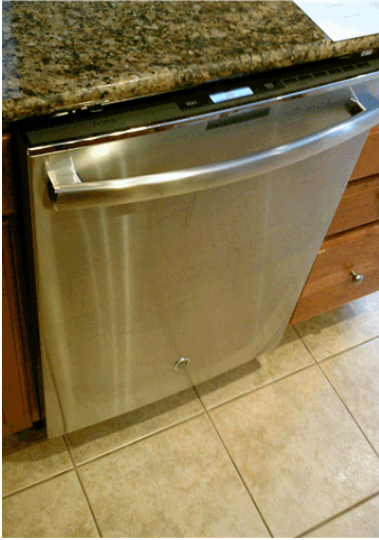
The dishwasher appeared to be in serviceable condition at the time of the inspection. This does not however guarantee future performance or conditions. The dishwasher unit was not secured properly to the cabinet. Recommend securing the dishwasher to the counter / cabinet.

Dishwasher was not secured to cabinets / countertop.

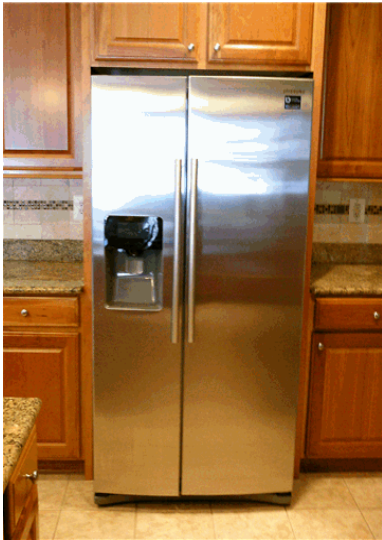
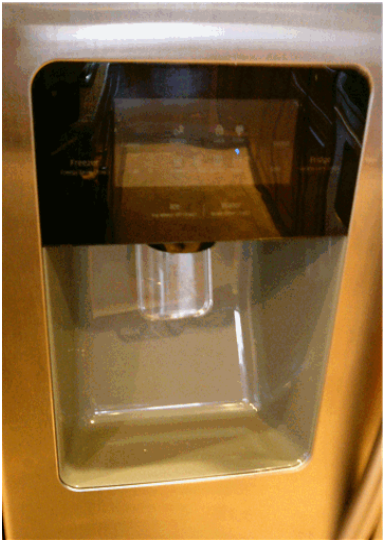
The inspector could not get the refrigerator's ice dispenser to properly function, and it appeared to be leaking at time of inspection. Recommend repair.

The inspector could not get the refrigerator's ice dispenser to properly function.

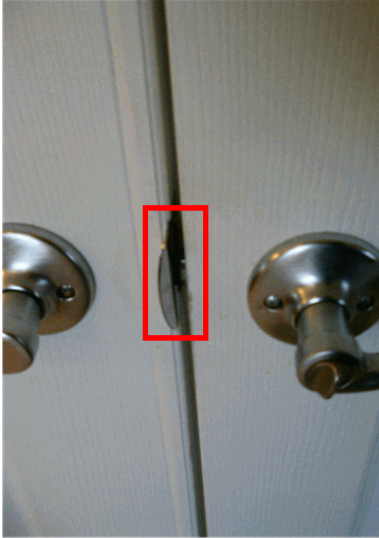
The master bathroom door did not properly latch at time of inspection. Recommend repair / adjustment.

The master bathroom door did not properly latch at time of inspection.

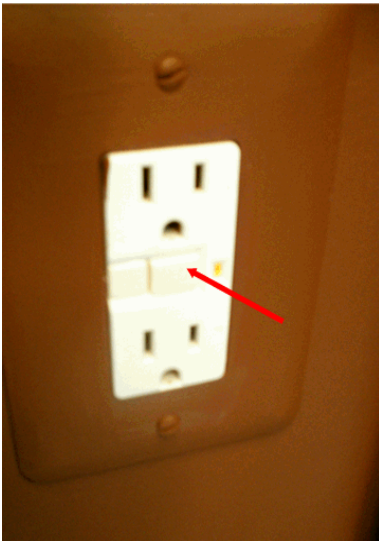
Electrical outlets in all baths are tied into GFIC in master bath. (Push here to reset)

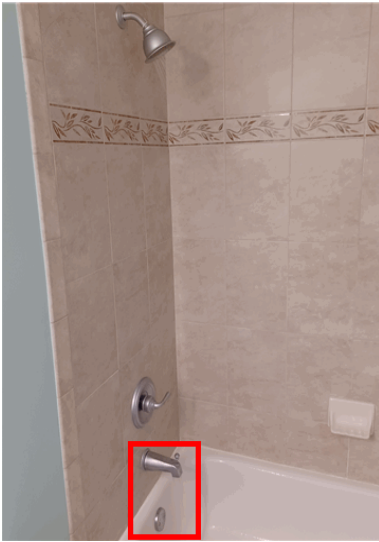
When the water was diverted from the tub spout to the shower head, some water was still running from the spout in the upstairs hallway bathroom. Adjustment or repair may be needed to the diverter faucet or tub spout. There was also water coming out of the back of the tub spout in the upstairs hallway bathroom. It is suggested that a "Licensed Plumbing Contractor" be contacted for further evaluation and repair. Water squirted out at the threads of the shower head in the master bathroom shower. Recommend repair.

Water came out of tub spout while shower was on in upstairs hallway bath. (Diverter issue)

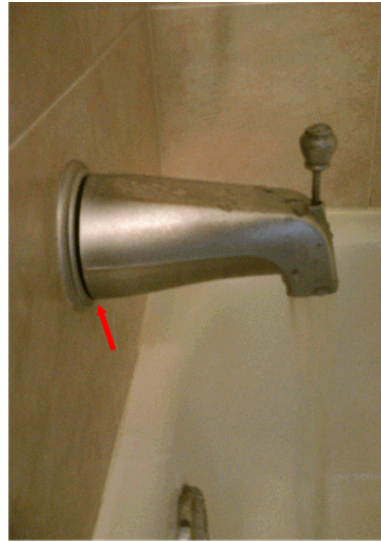
There was also water coming out of the back of the tub spout in the upstairs hallway bathroom.

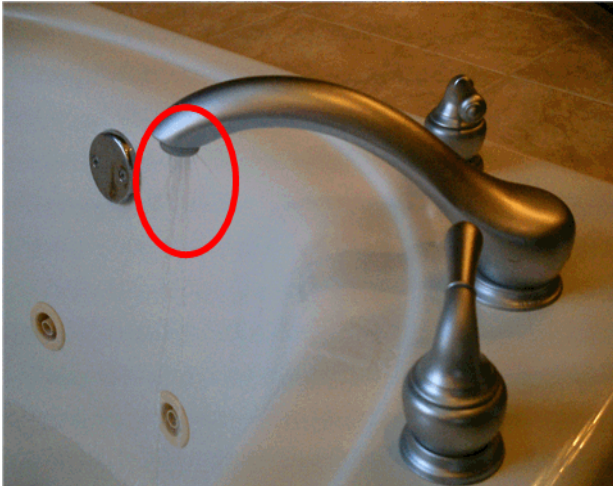
A whirlpool tub was noted in the master bathroom. The tub was filled to a level above the water jets and operated to check the intake and jets. Pump and supply lines were not completely accessible. The jets appeared to be in serviceable condition at the time of inspection, but the tub took way longer than it should (2 hours) to fill up past the level of the jets. It is suggested that a "Licensed Plumbing Contractor" be contacted for further evaluation and repair.

The whirlpool tub took way longer than it should (2 hours) to fill up past the level of the jets.

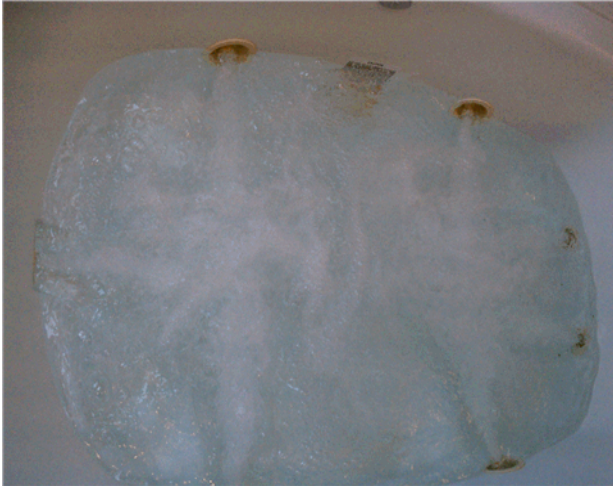
The whirlpool jets functioned properly when tested.

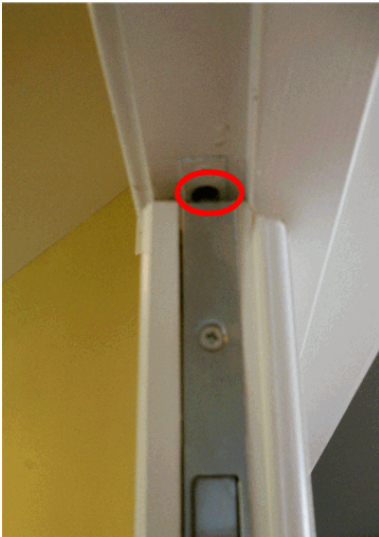
The top lock on the double doors to the back right room on main level did not line up with the hole.

The frame (top) lock on the double doors to the back right room on the main level did not line up with the hole. The master bedroom door was damaged at the top by the lock. The door to the front right upstairs bedroom would not properly latch. The locks at the top of the closet doors in the front right upstairs bedroom were damaged. The left closet door in the master bedroom sticks at the door-frame. Repairs and / or adjustments are recommended.

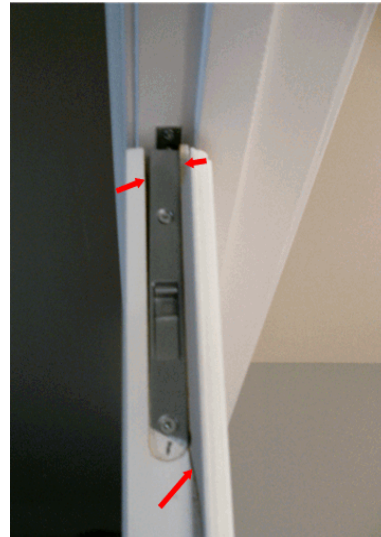
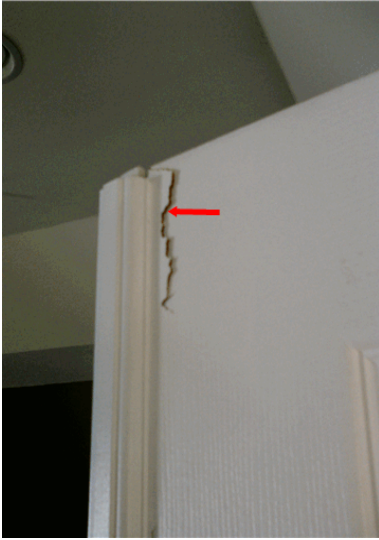
The master bedroom door was damaged at the top by the lock.

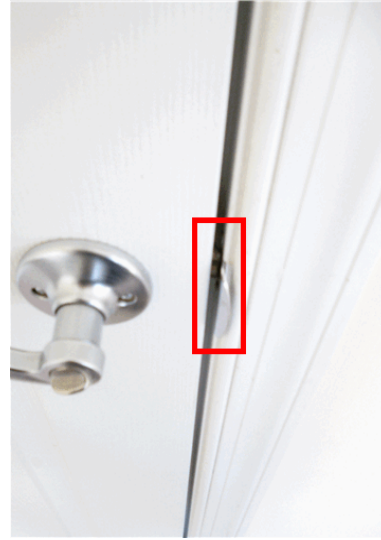
The door to the front right upstairs bedroom would not properly latch.

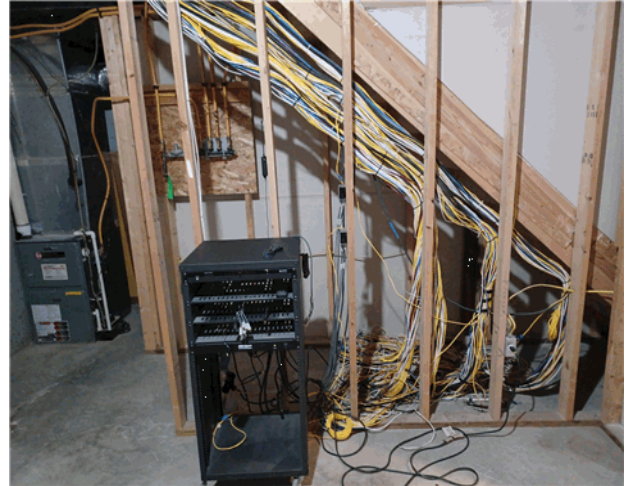
Testing alarm / low voltage systems is out of scope of a standard home inspection.

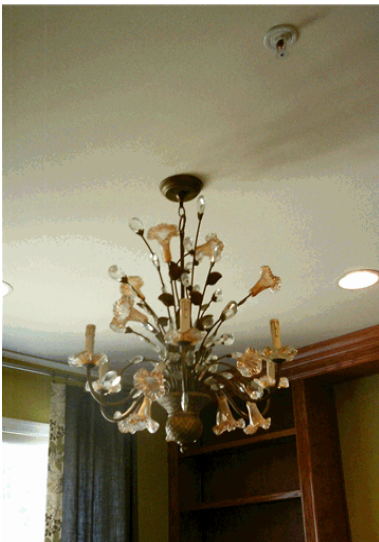
The chandelier in the back right room on the main level was inoperative at time of inspection. Dismantling and testing of all light fixtures is not performed as part of this inspection. Recommend all lights be operable prior to close. In the rooms without a switched ceiling / wall light, one of the electrical outlets is operated by a switch. These are the outlets designed to plug lamps into. Recommend not plugging anything into those outlets that you would not want turned off every time the switch is turned off.

The chandelier in the back right room on the main level was inoperative. (No light bulbs)

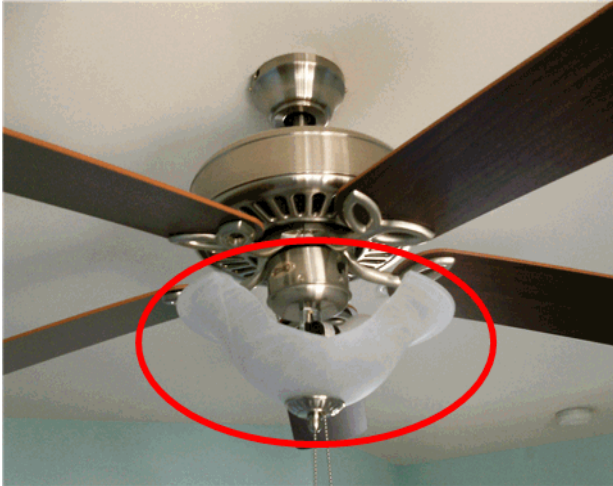
The light was inoperable and the globe / cover was broken at the ceiling fan in the back right upstairs bedroom. Recommend repair.

light was inoperable and cover was broken at the ceiling fan in the back right upstairs bedroom.

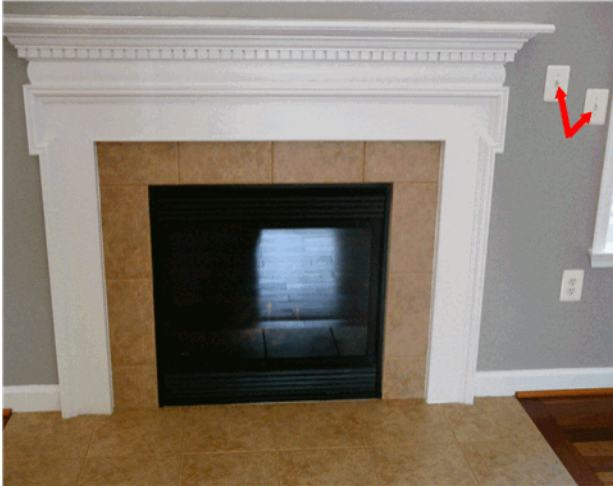
These switches operate the gas fireplace.

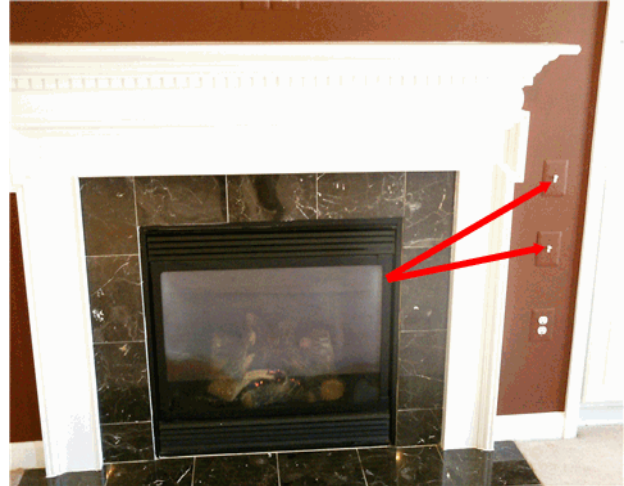
These switches operate the gas fireplace.

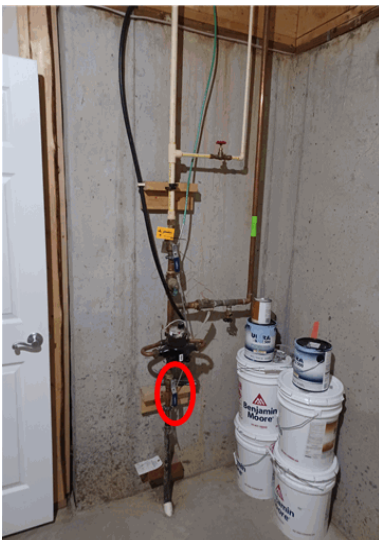
Main water shut-off. (Shuts off water to entire home)

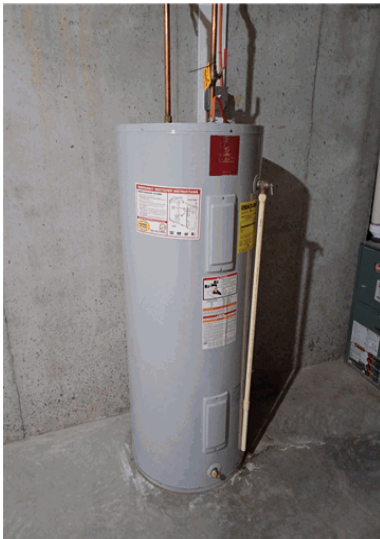
The water heater was operable at the time of inspection, but due to the age and / or conditions observed (rust at the bottom), the water heater is past the end of its useful life. Replacement is recommended in the near future before it completely fails and floods the basement.

Rust and water stains at the bottom are sure signs that the water heater is about to completely fail

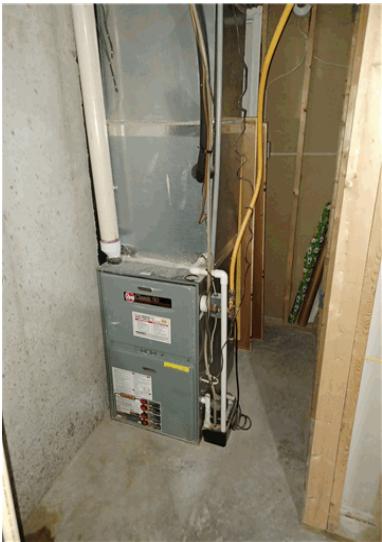
The furnace in the basement turned on, but the gas flame never fired up when tested, so the heating system was blowing cold air. It is suggested that a "Licensed HVAC Technician" be contacted for further evaluation and repair. The heating system located in the attic was operational at time of inspection. This is not an indication of future operation or condition.

The furnace in the basement turned on, but the gas flame never fired up to heat the air.

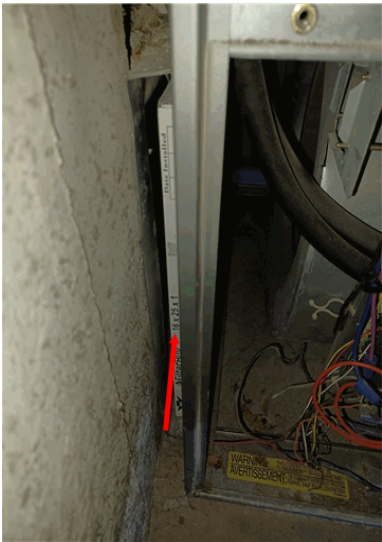
16"x25"x1" air filter goes here. (Unit in Basement) (Replace every 30-90 days)

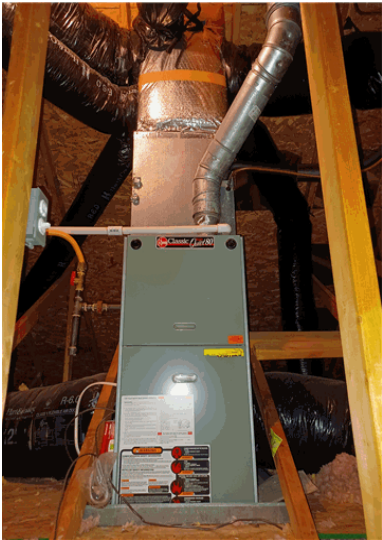
Unit in attic was in serviceable condition at time of inspection.

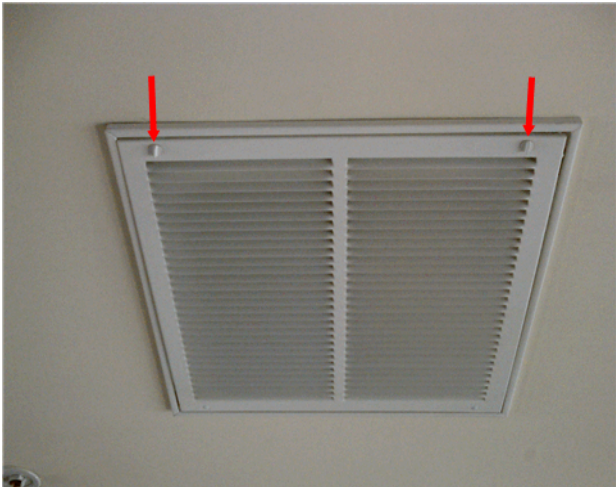
16"x16"x1" air filter goes here. (1 of 2 upstairs) (Replace every 30-90 days)

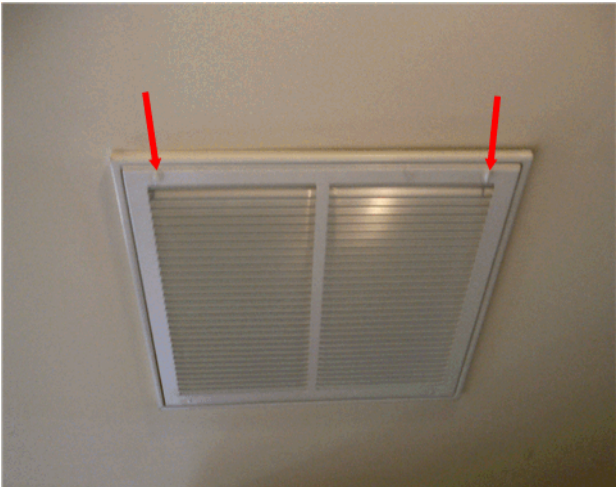
16"x16"x1" air filter goes here. (1 of 2 upstairs) (Replace every 30-90 days)

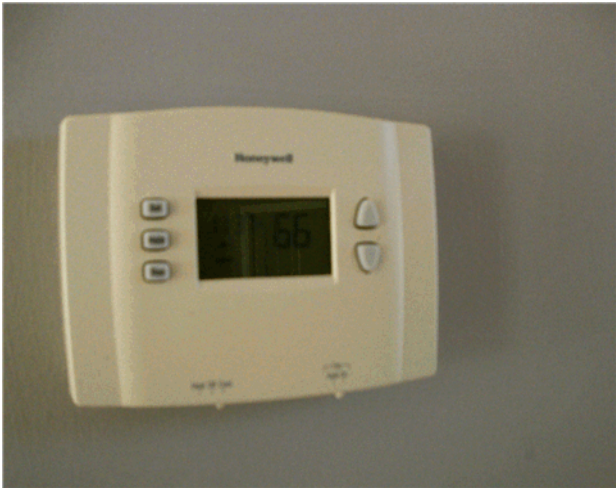
Thermostat on main level controls temperature on main level and basement.

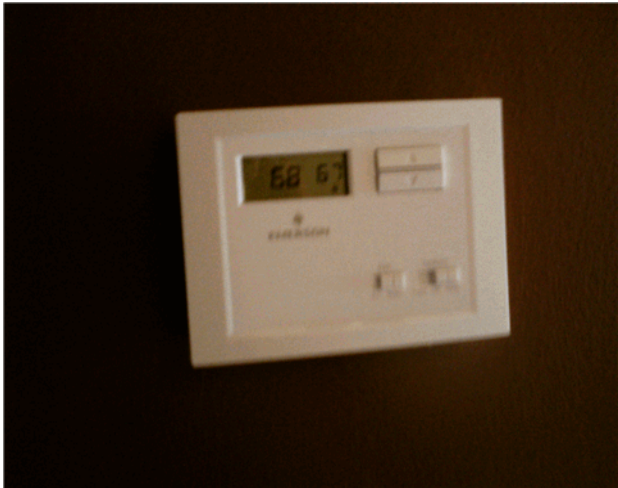
Thermostat on second level controls temperature on the top level.

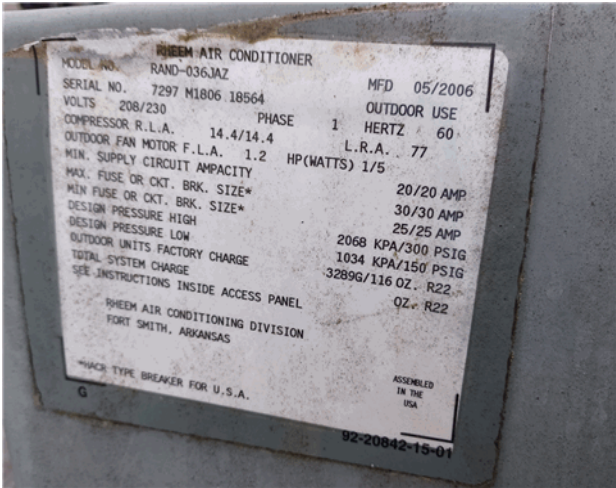
90) Cooling System                      5/06 (Both outside AC units) (Month/Year)  
Date of Manufacture
